**MERSEYSIDE  
FIRE & RESCUE  
SERVICE**

**Fire Investigation Report 132-20**

**Ørsted BESS,**

TYPE OF PROPERTY: Battery energy storage site BESS

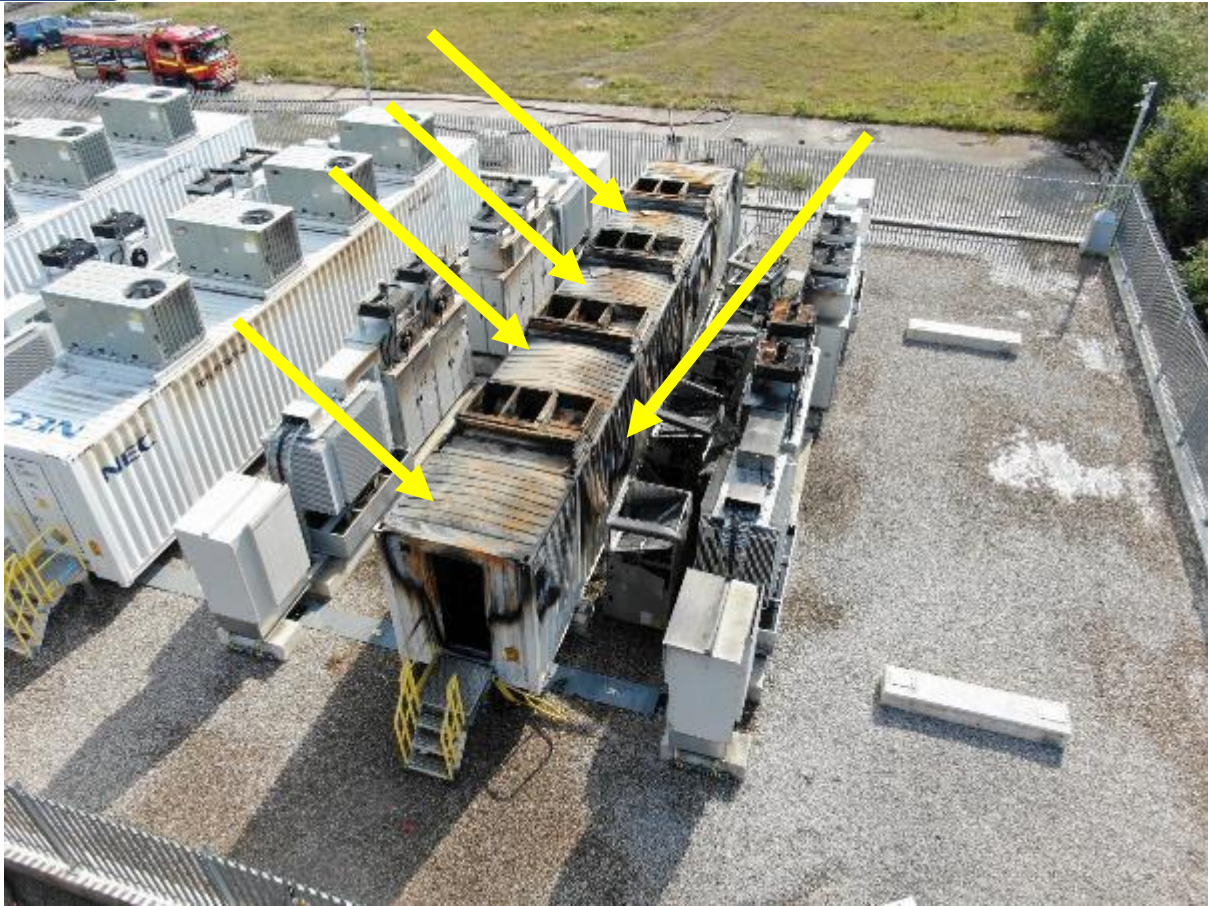
- 4.3 The container affected by fire was at the end of the row, it exhibited clear signs of pressure building-up and deflagration. This was evident by the expansion and distortion of the sides and top of the container.

*Image 2 shows the damaged container with signs of expansion/distortion that is equal across the container and not localised to the area of the initial failure.*

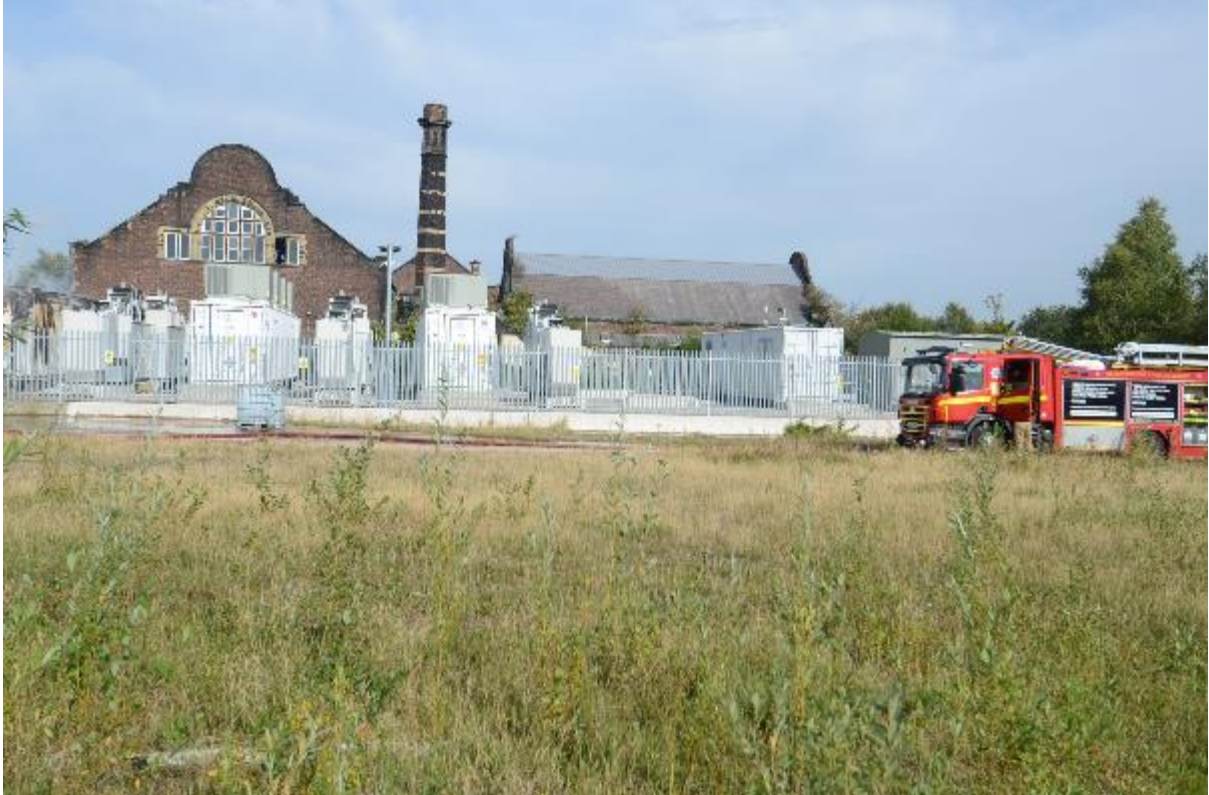
1

Overview of the scene

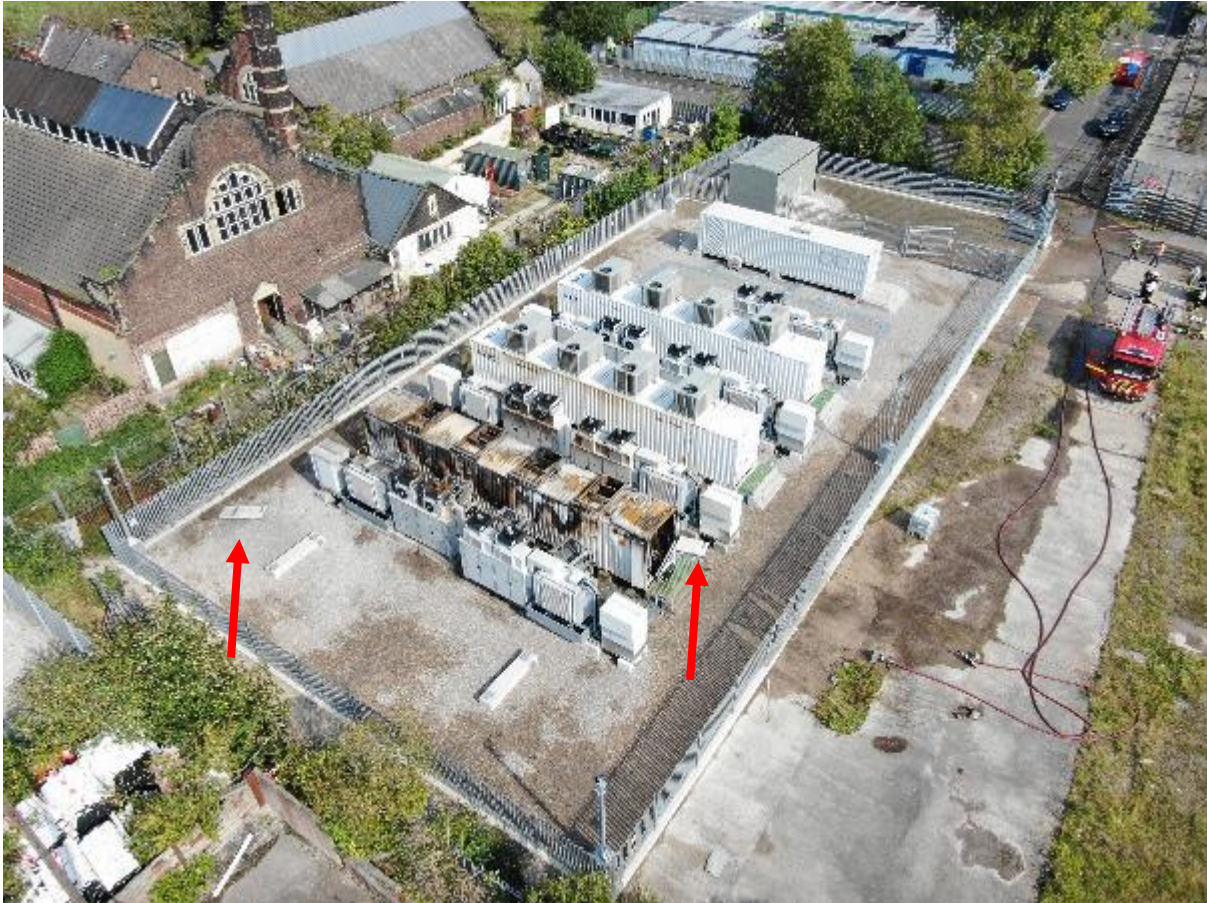
2

- The door closest to The Fisheries had been blown off its hinges and had ripped through the yellow safety rails before landing in the compound. These doors are of substantial weight and it would have taken great internal pressure and force to eject them to the distance observed.

Air unit overview. The red arrows show the resting place of the doors

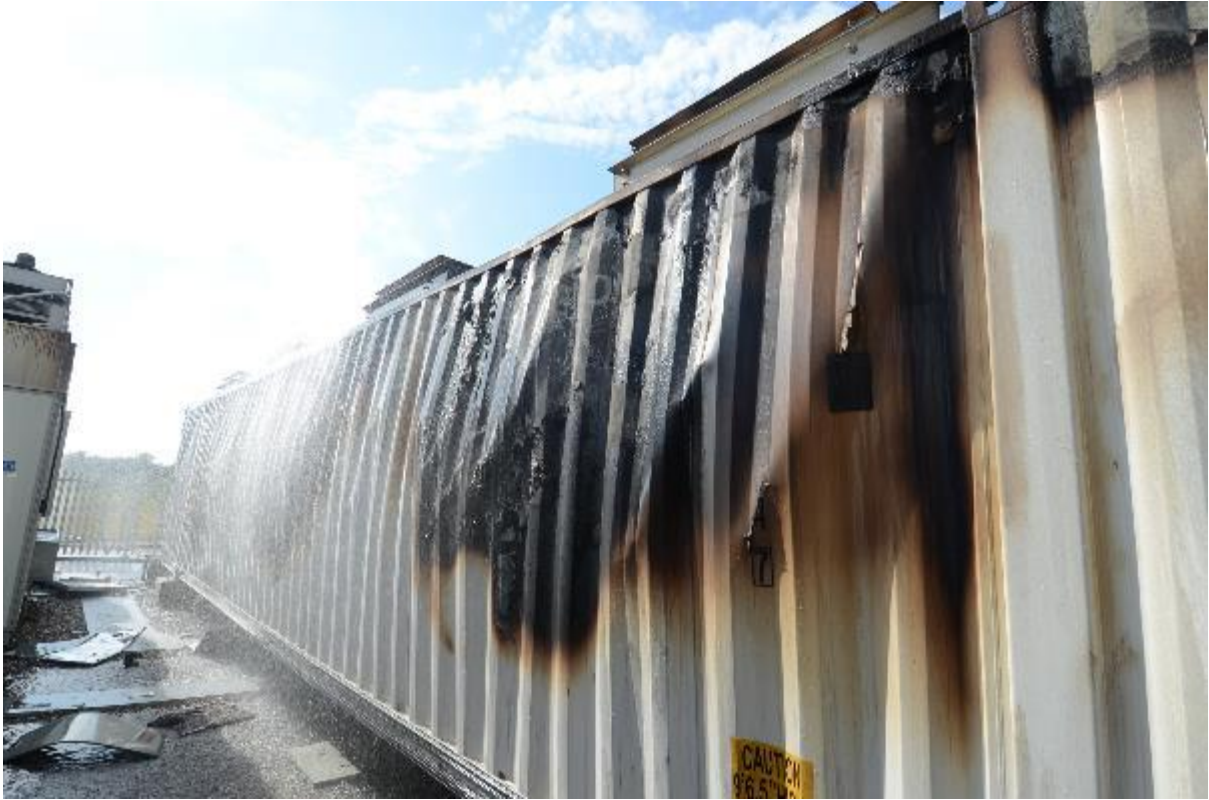
3

Left aspect of container 1

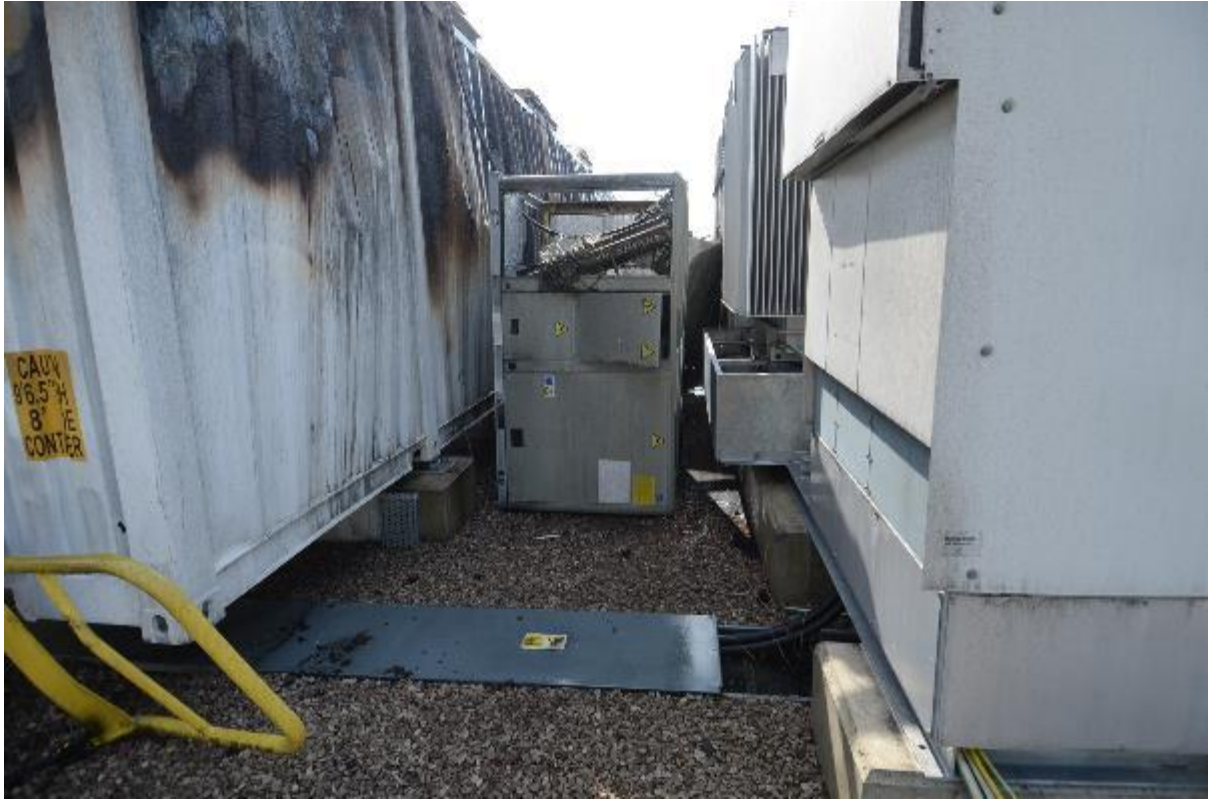
4

Right aspect of container one

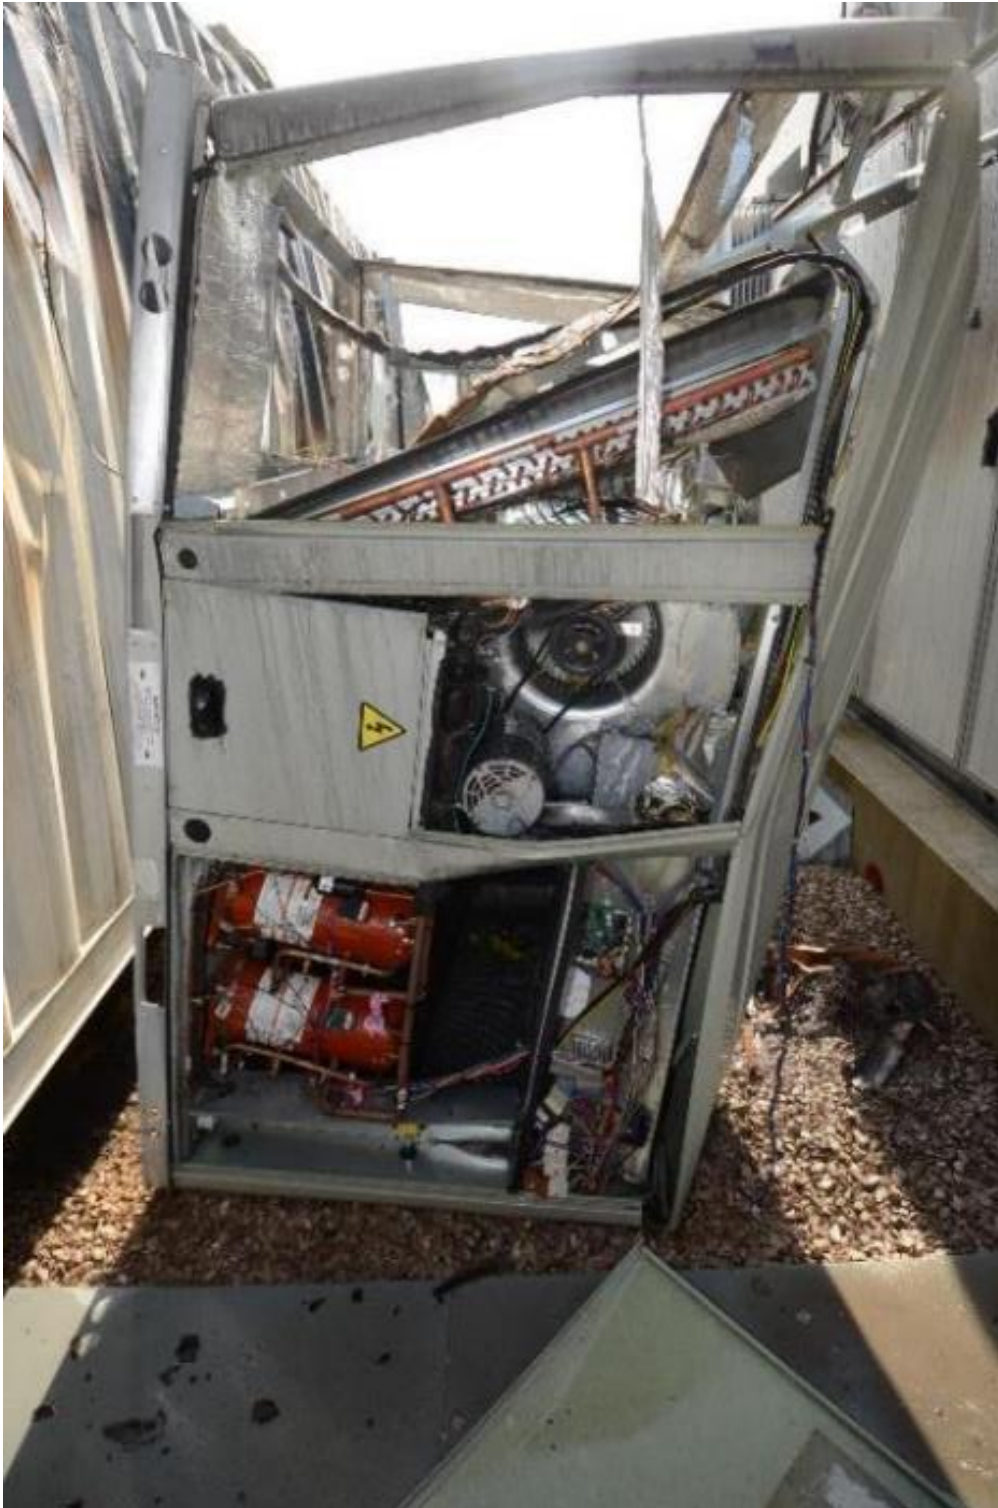
- All four HVACs had come detached from their fittings and landed in a row alongside the container and did not display much fire damage (see photo 4 & 5 in section 13).

HVACS after coming dismounted from the container roof

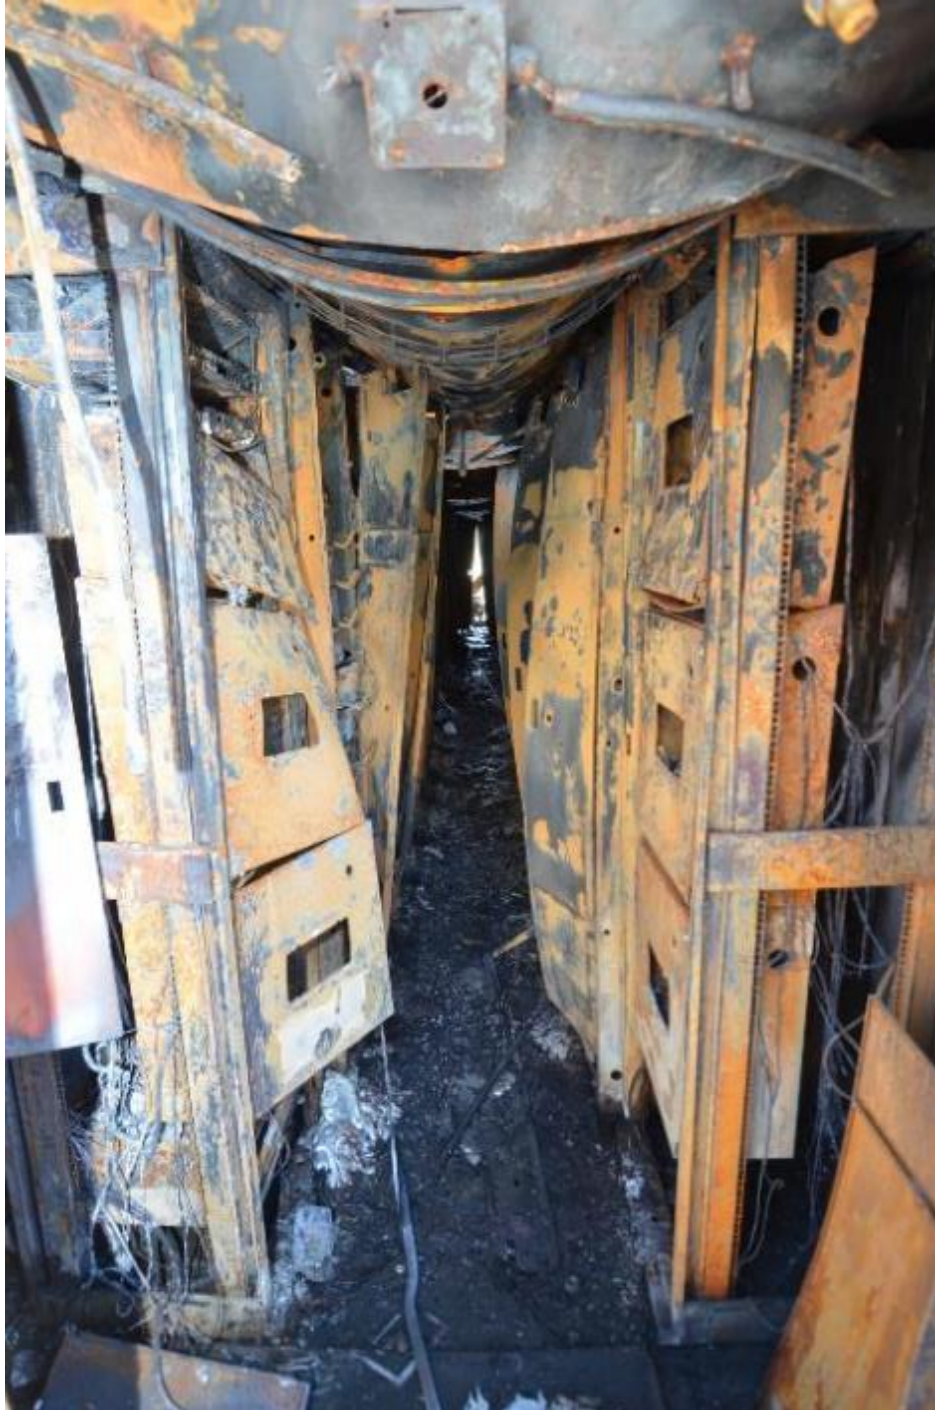
- The internal racking and contents had been extensively damaged and there was significant evidence that the internal container suffered weakening from the heat and the blast (see photo 6 section 13).

Internal view of container one from the Fisheries side

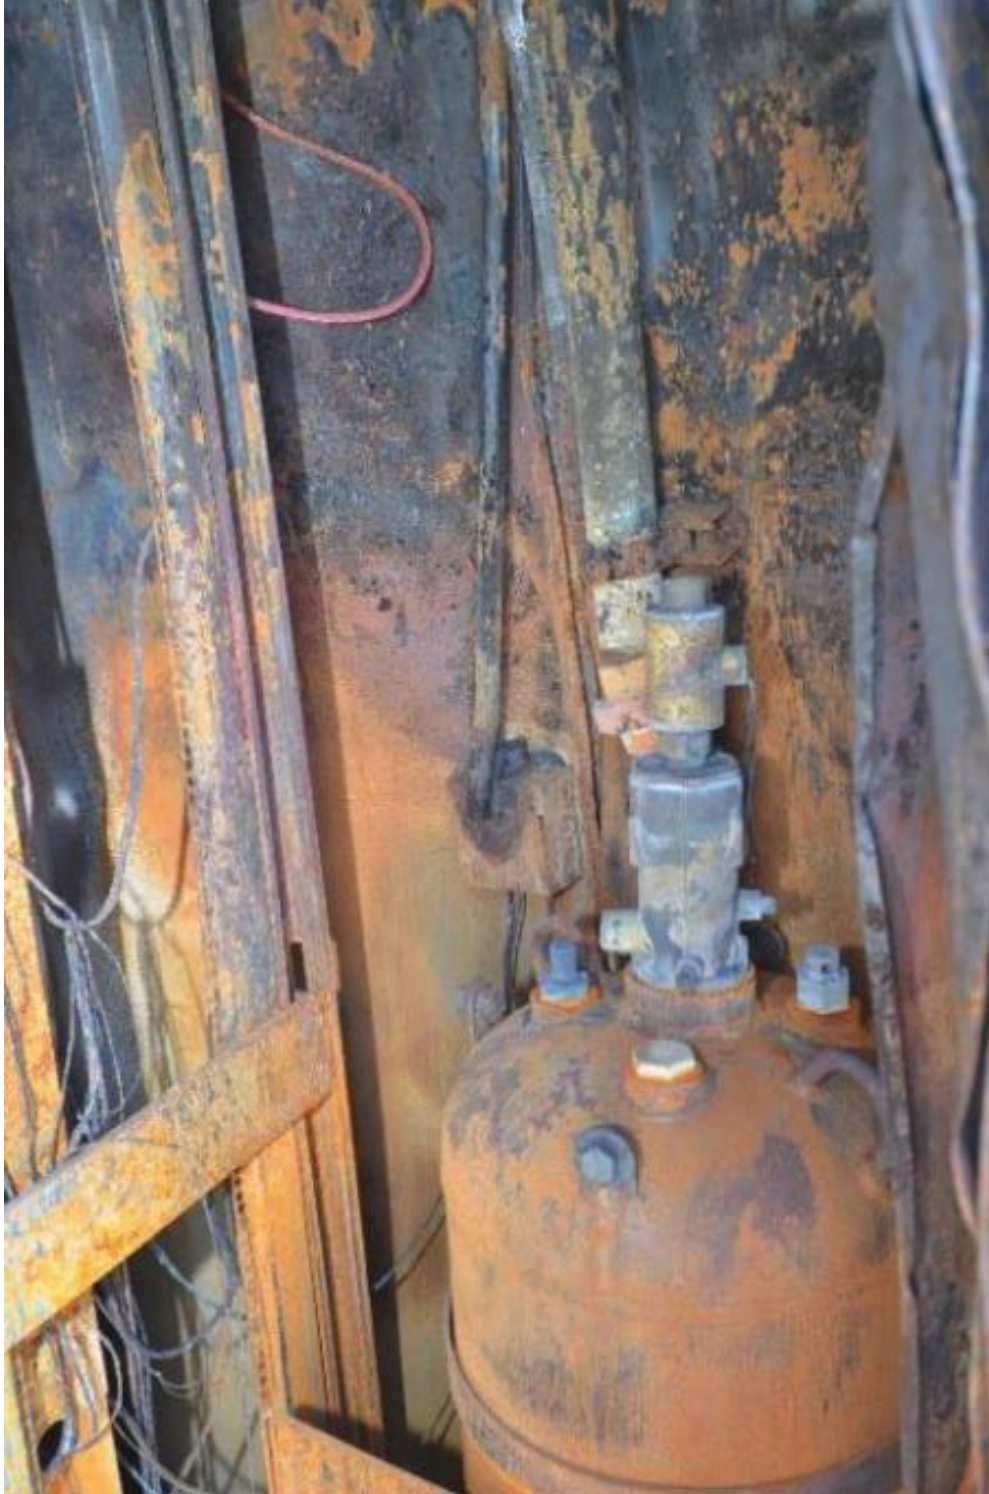
- On inspecting the suppression pipework, I noted that the discharge heads were missing and only appeared to have been attached by three threads. The responsible person informed me that PTFE tape and lock tight sealant was used to keep the heads in place.

NOVEC system in container one with damaged pipe work

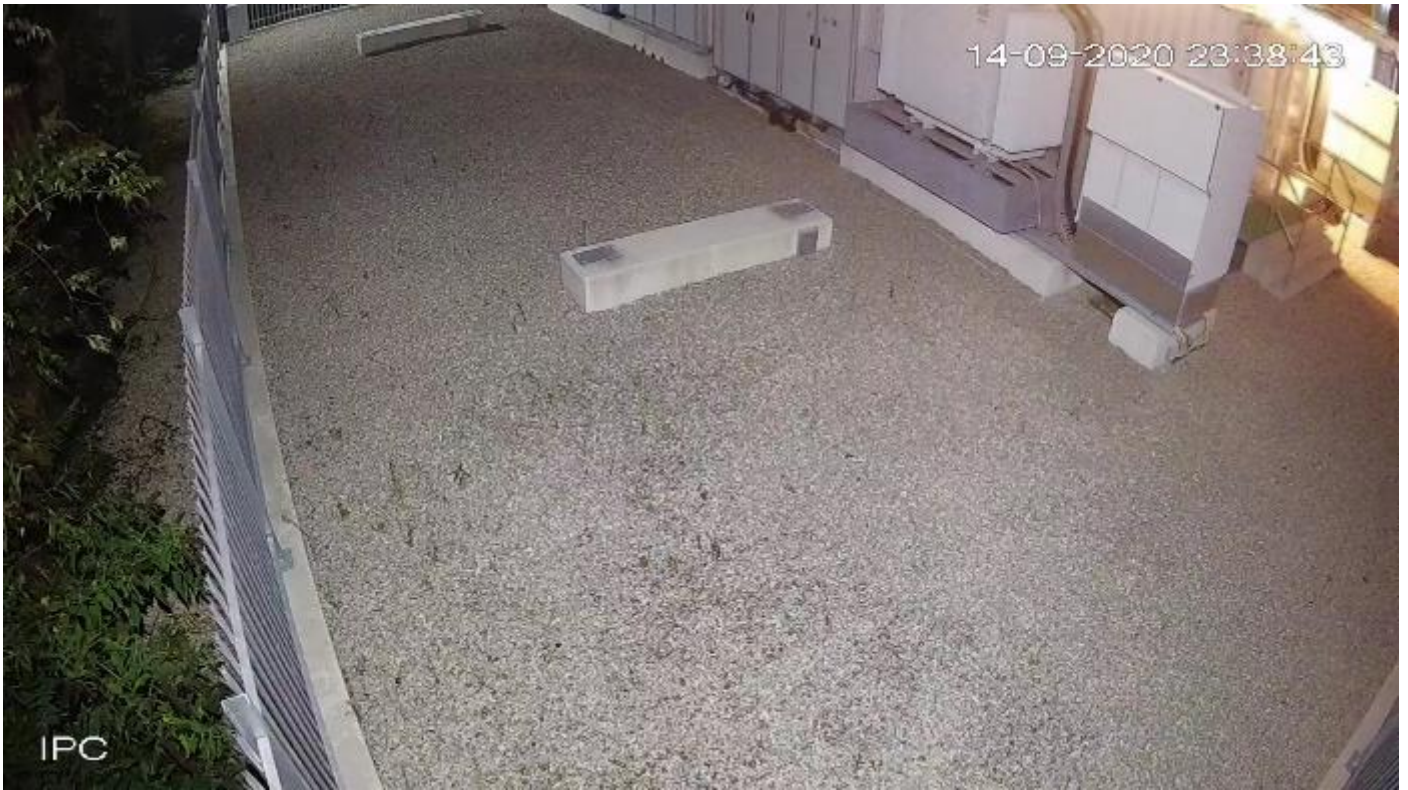
12

External CCTV at point of blast for the door fails

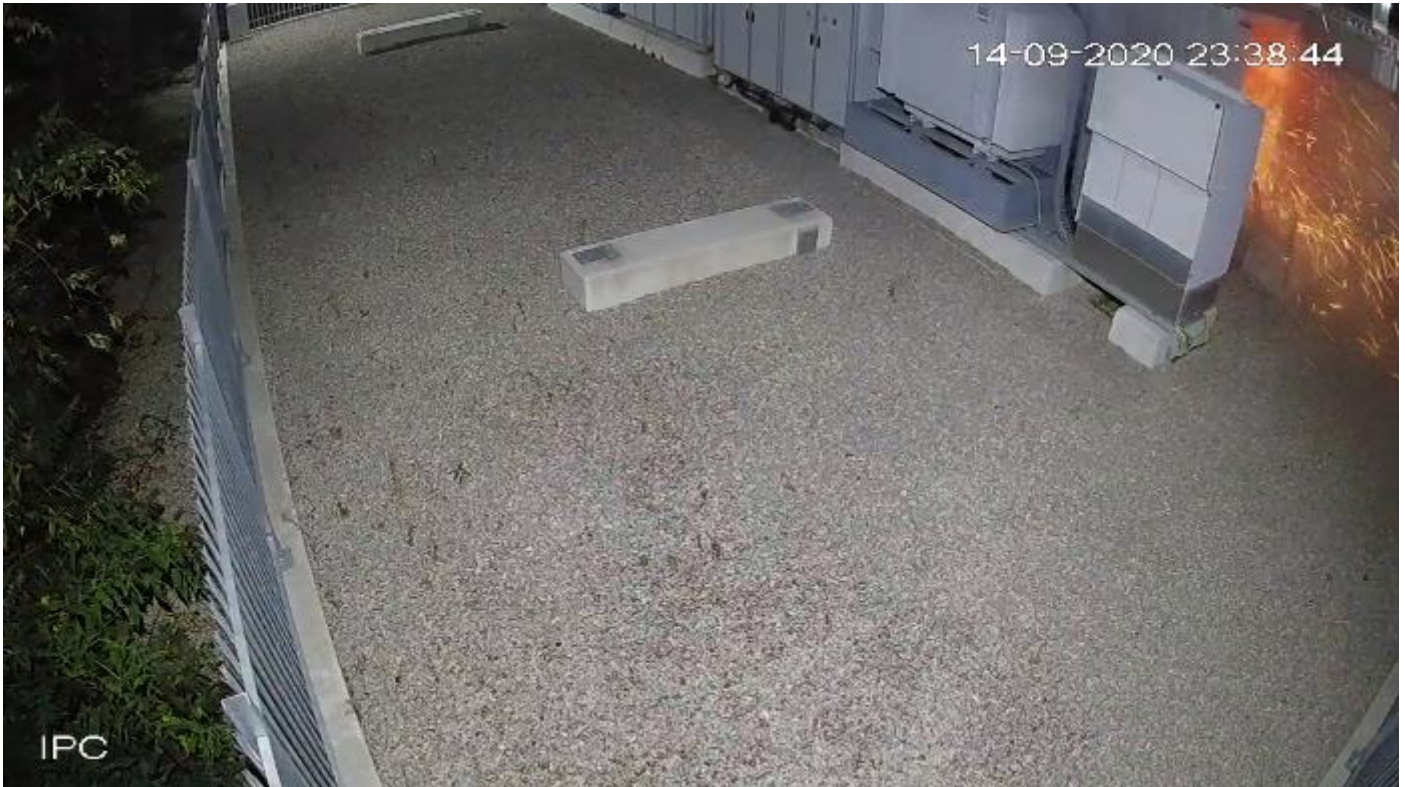
13

External CCTV showing flaming discharge consistent with a failing Lithium cell

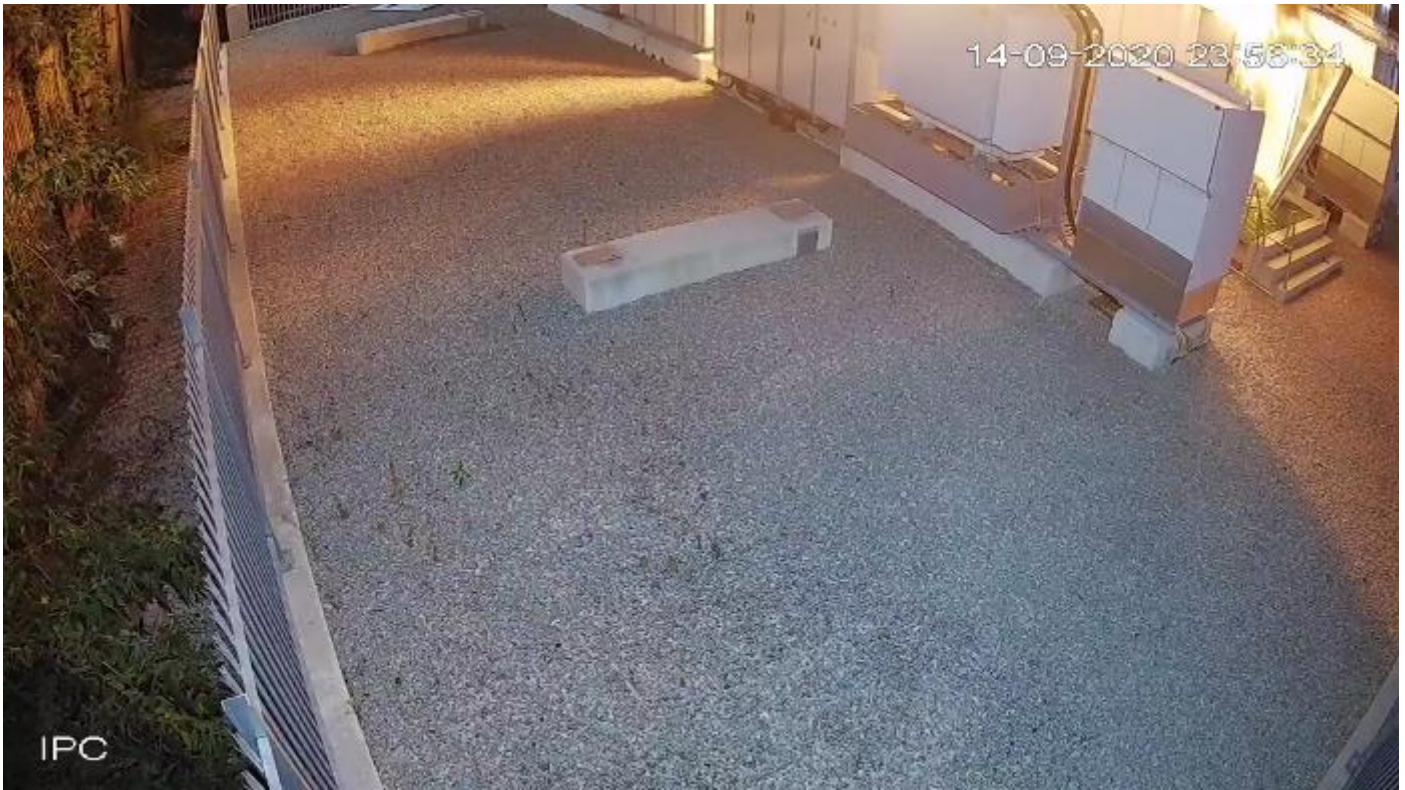
External CCTV showing the door being blown open and the smaller door coming detached

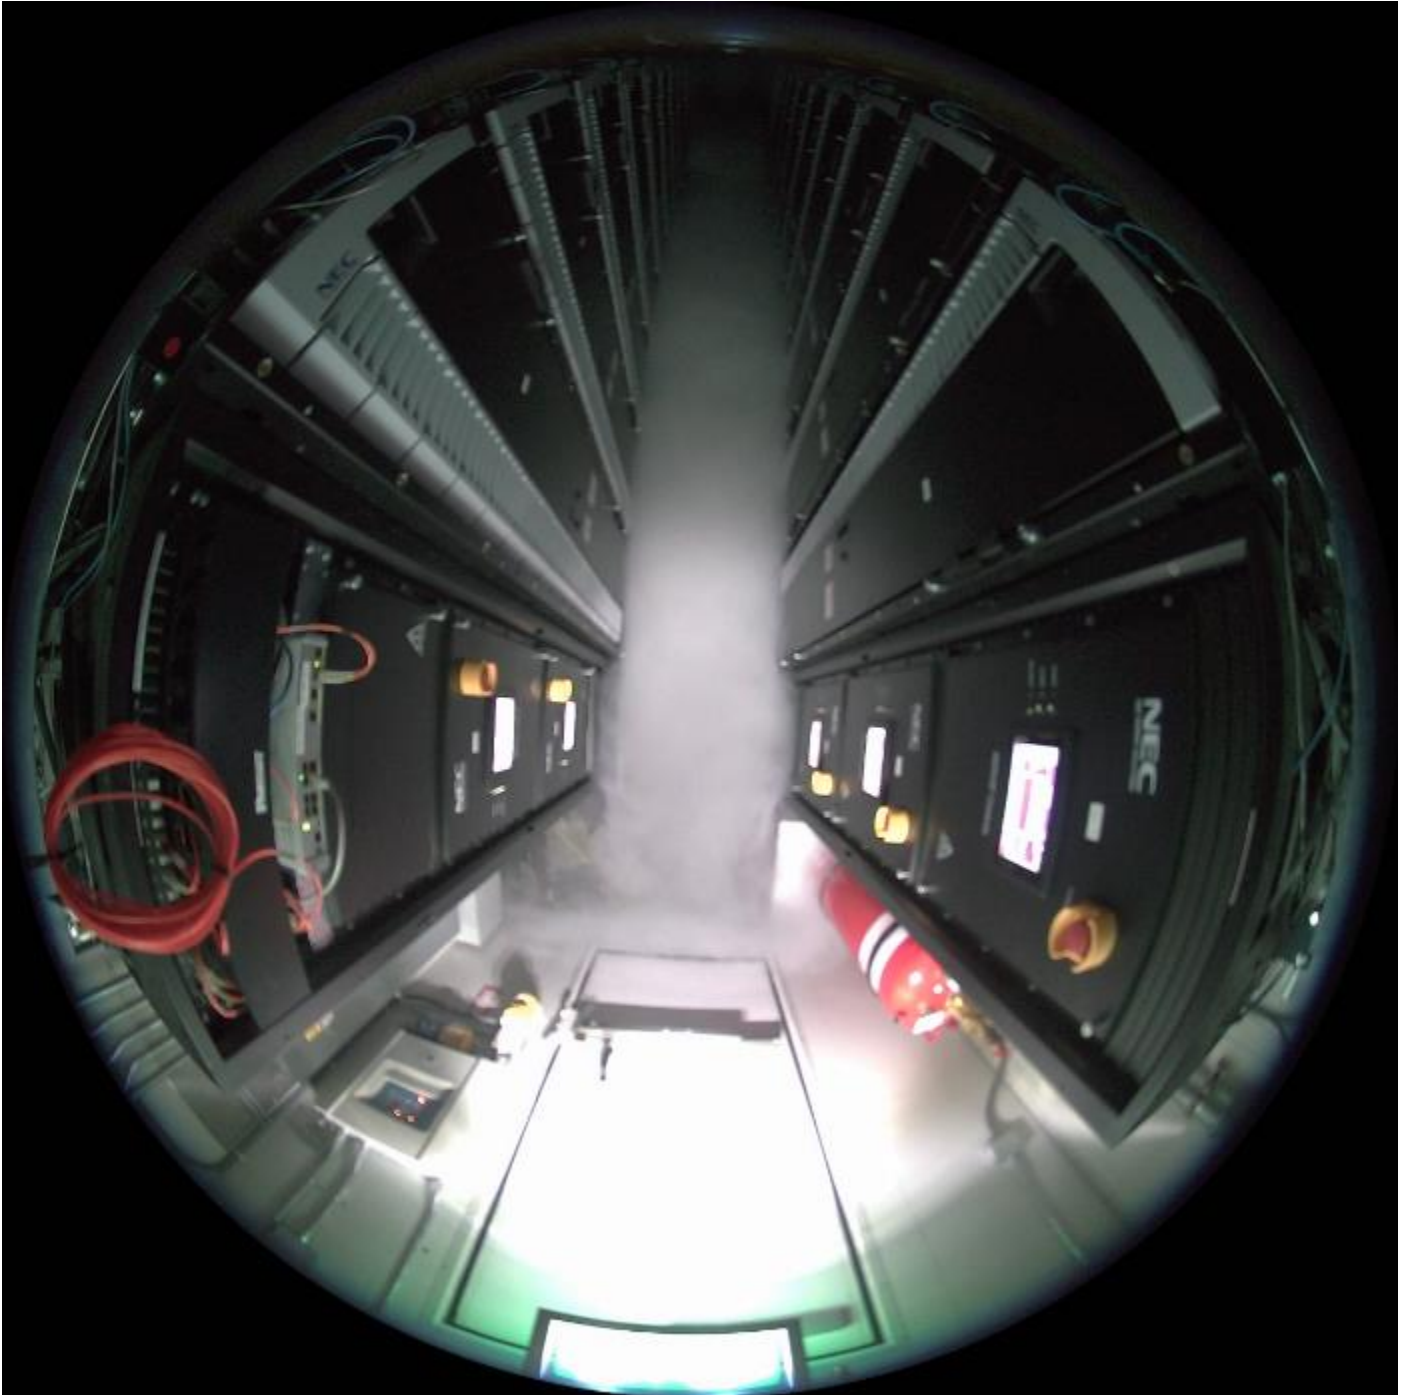
Internal CCTV showing the activated alarm panel to the bottom left, the NOVEC system to the bottom right and the fire exit door in the bottom centre. The fish eye view is due to the position of the CCTV camera located on the ceiling near the rear door. A vapour cloud can be scene within the container

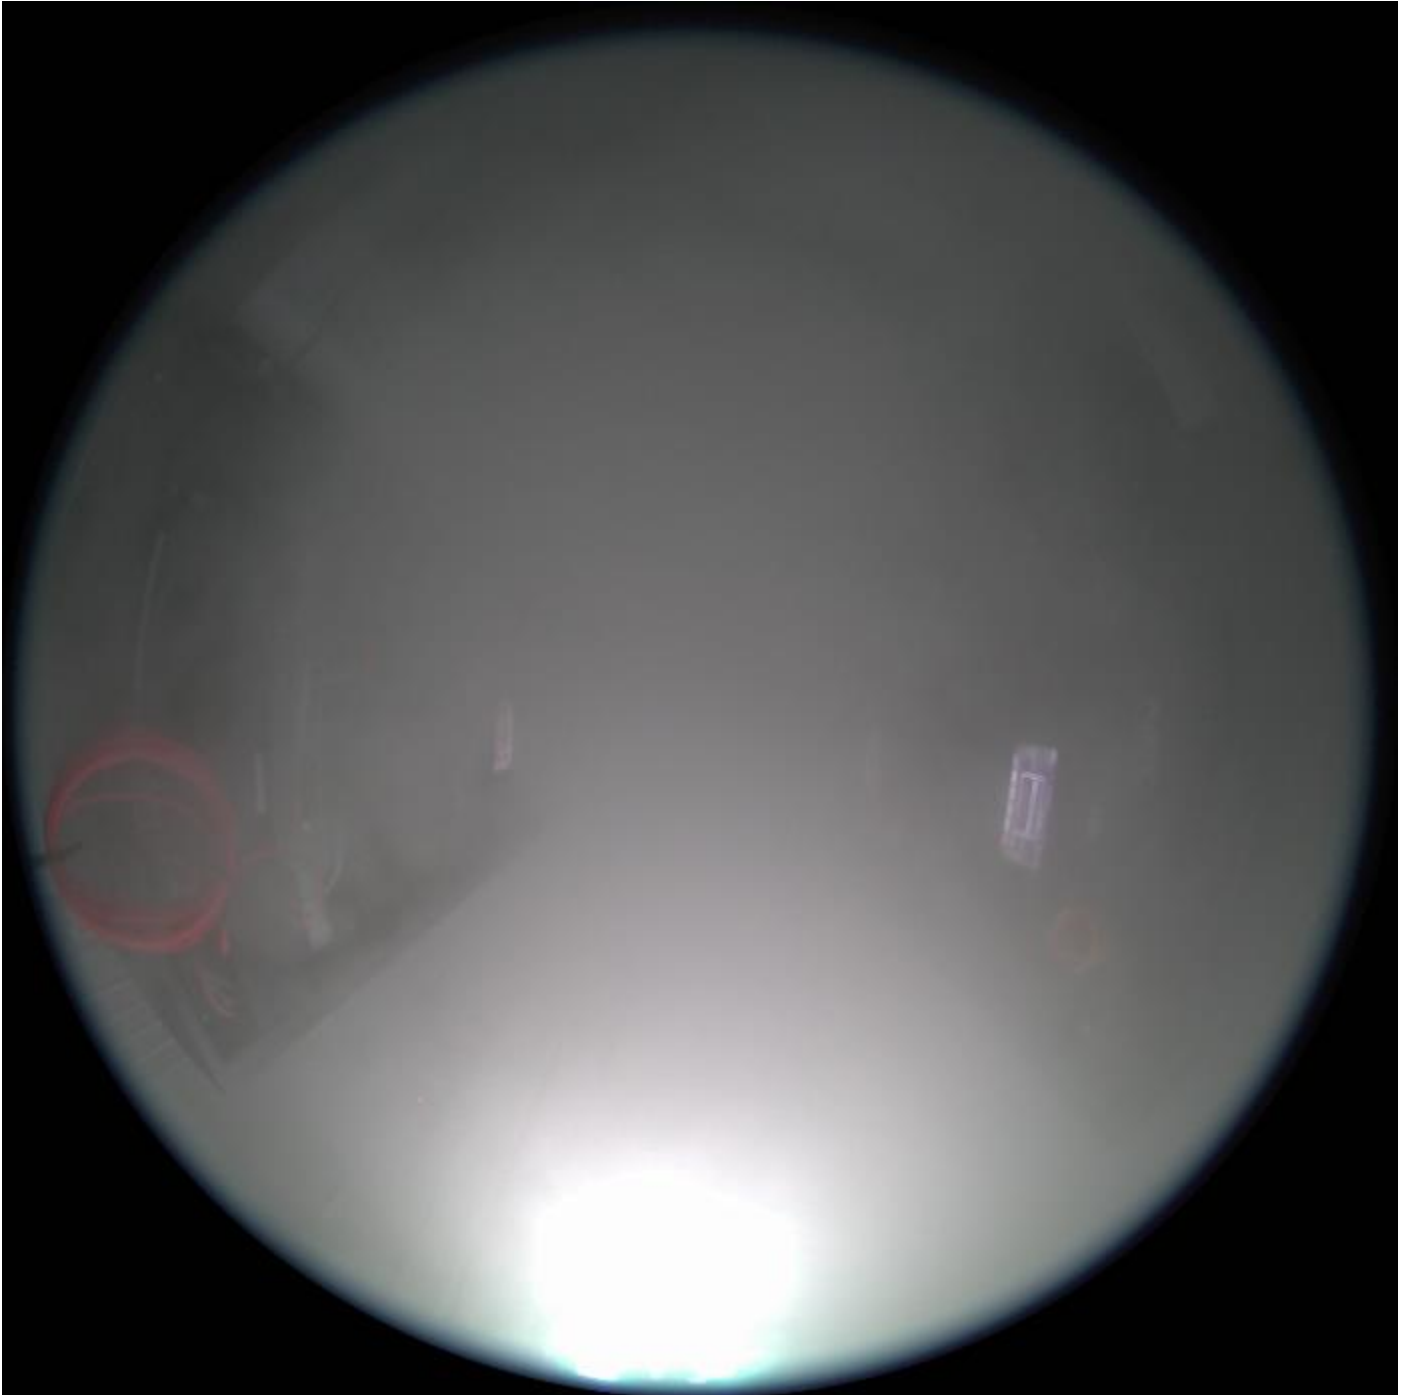
16

Internal CCTV 00:37 vision begins to become obscured by the vapour cloud

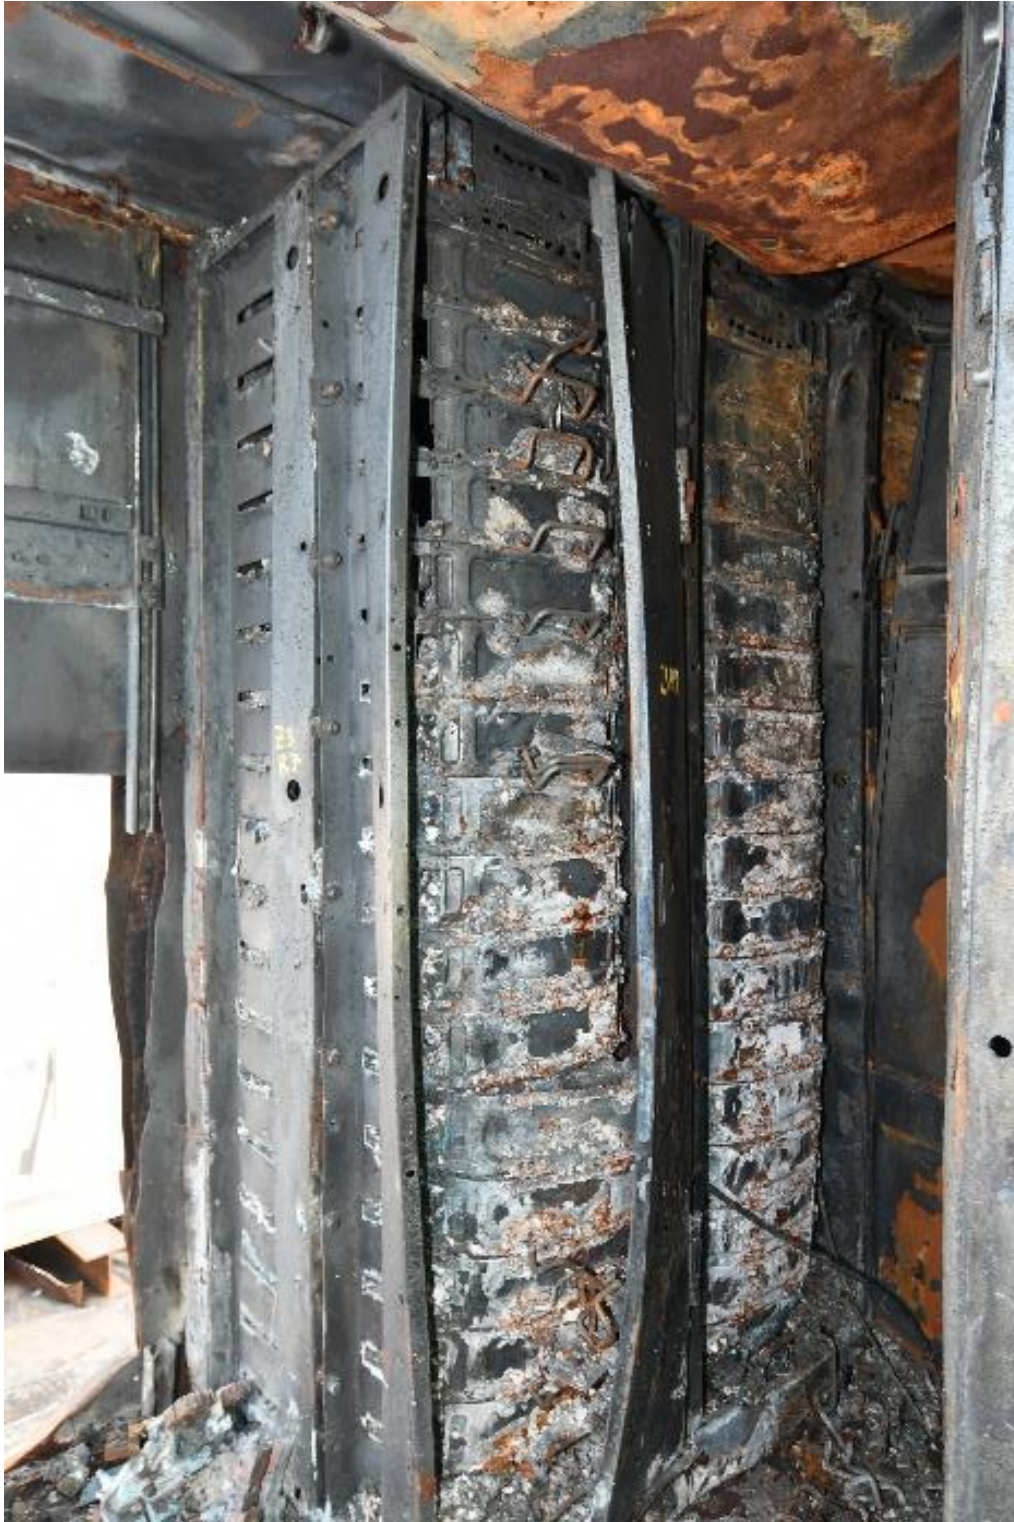
18

Image MB0\_7375 shows R7 Z3 after the containers had been cut in to sections.

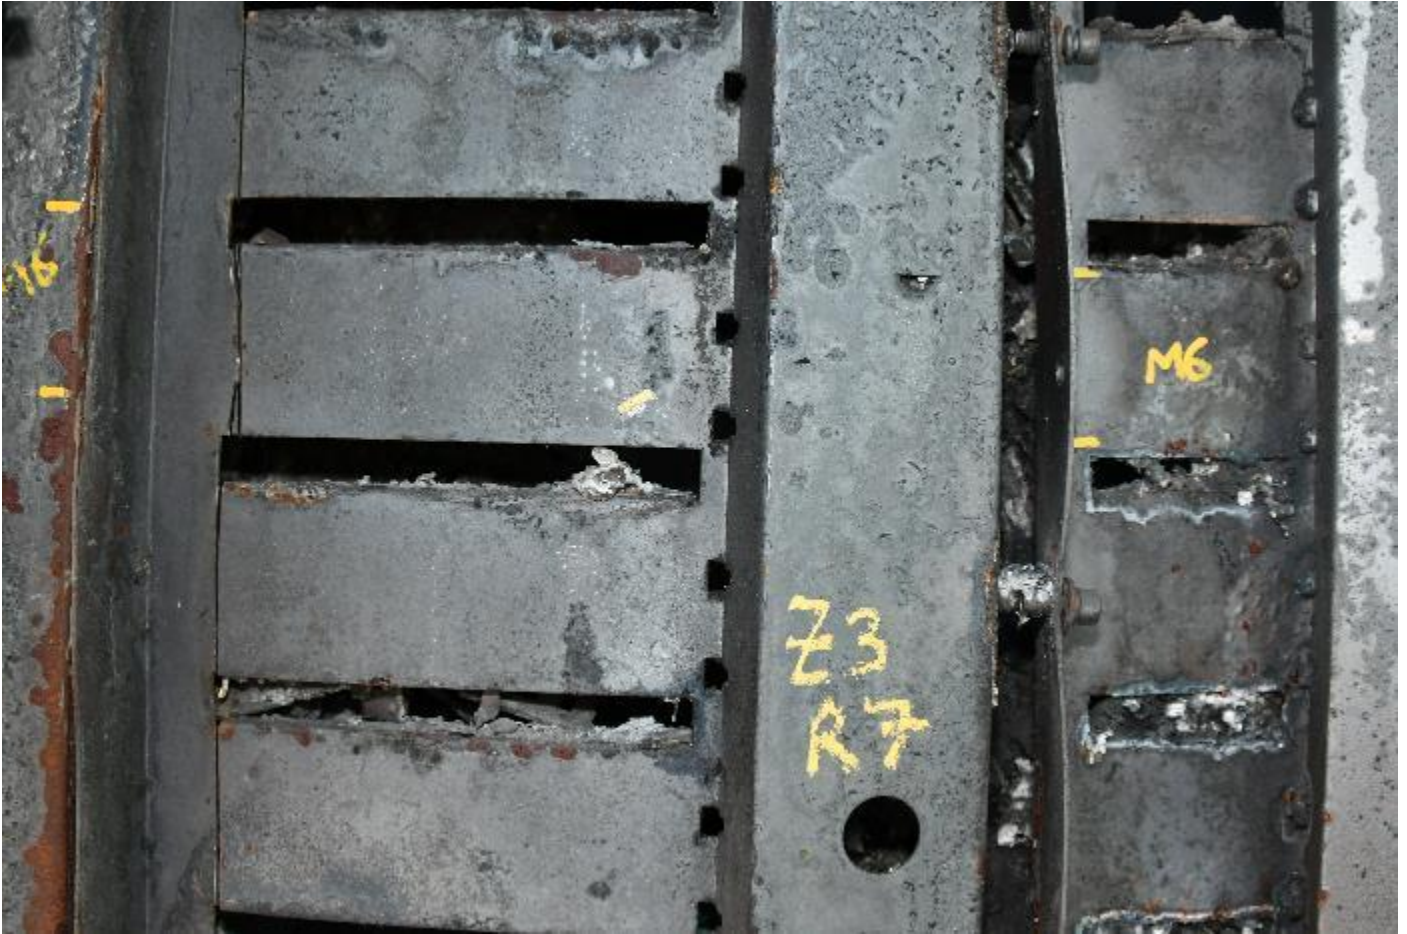
19

Image MB0\_7397 shows where module 6 would have been pre fire. The modules had melted and collapsed.

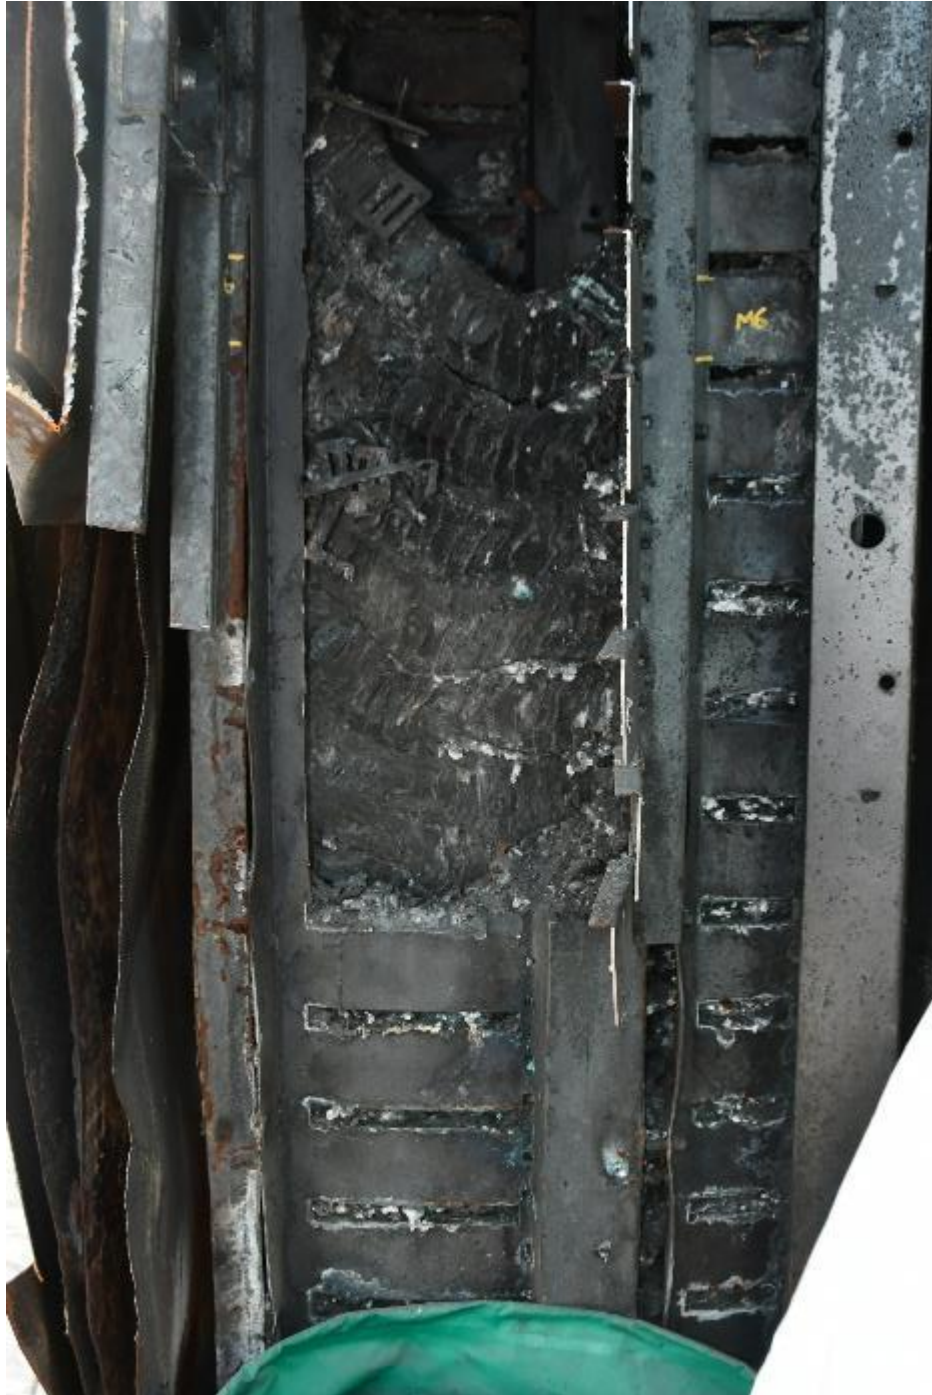
20

Image MBO\_7402 shows the side view of R7 after the side of the rack had been cut away. This view shows how the modules have collapsed making recover difficult. To remove them through the front would have pulled the module apart so, they had to be recovered sideways.

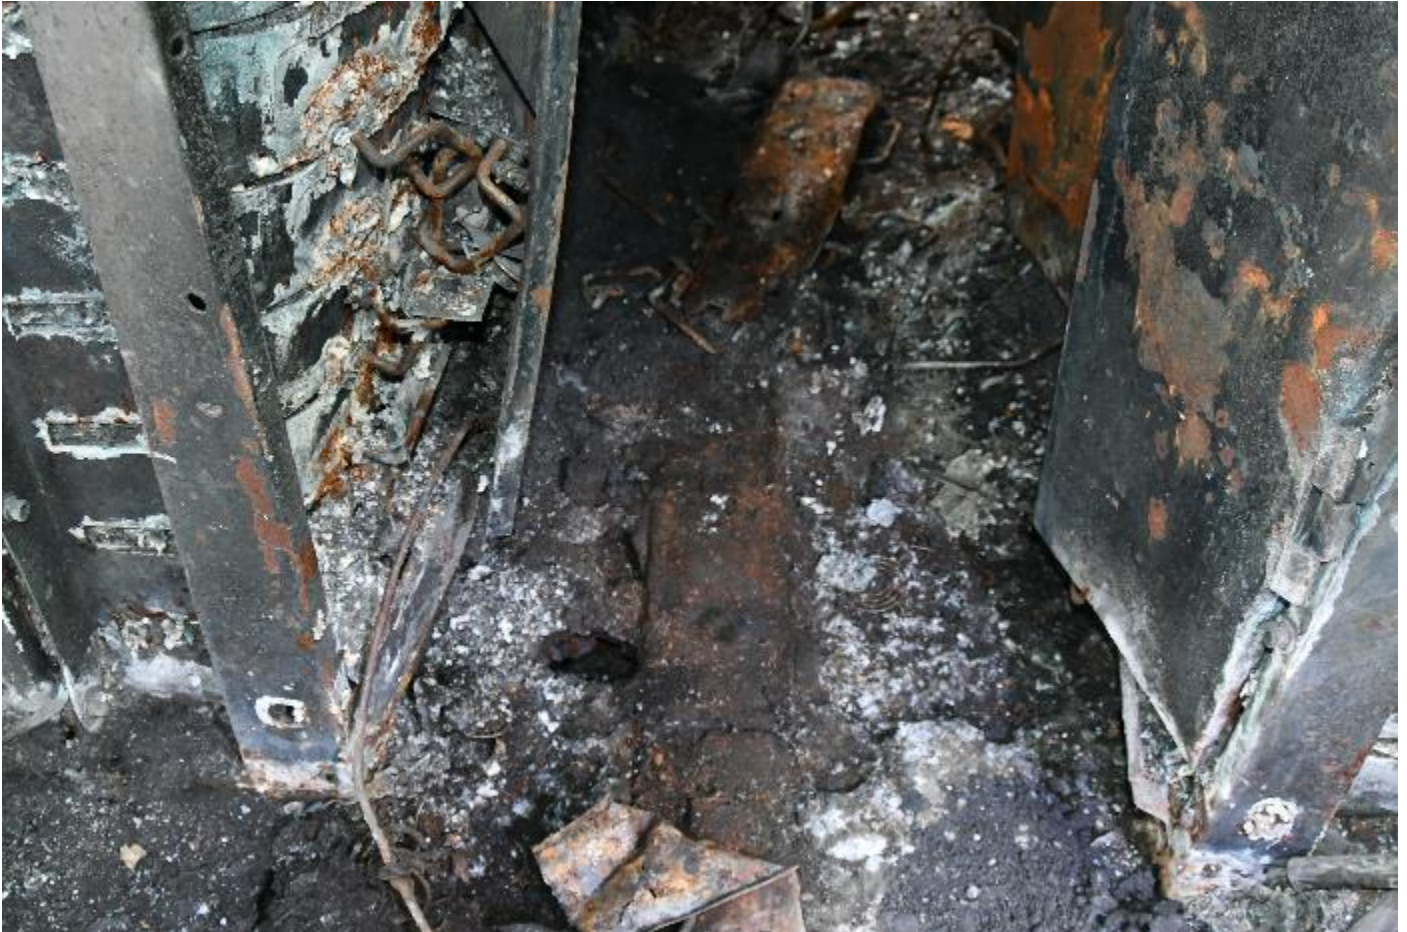
22

Image MB0\_7450 shows the flooring at the foot of R7. The floor had wood boarding fitted which had burnt through.
