**MERSEYSIDE  
FIRE & RESCUE  
SERVICE**

**Fire Investigation Report 132-20**

**Ørsted BESS,**

TYPE OF PROPERTY: Battery energy storage site BESS

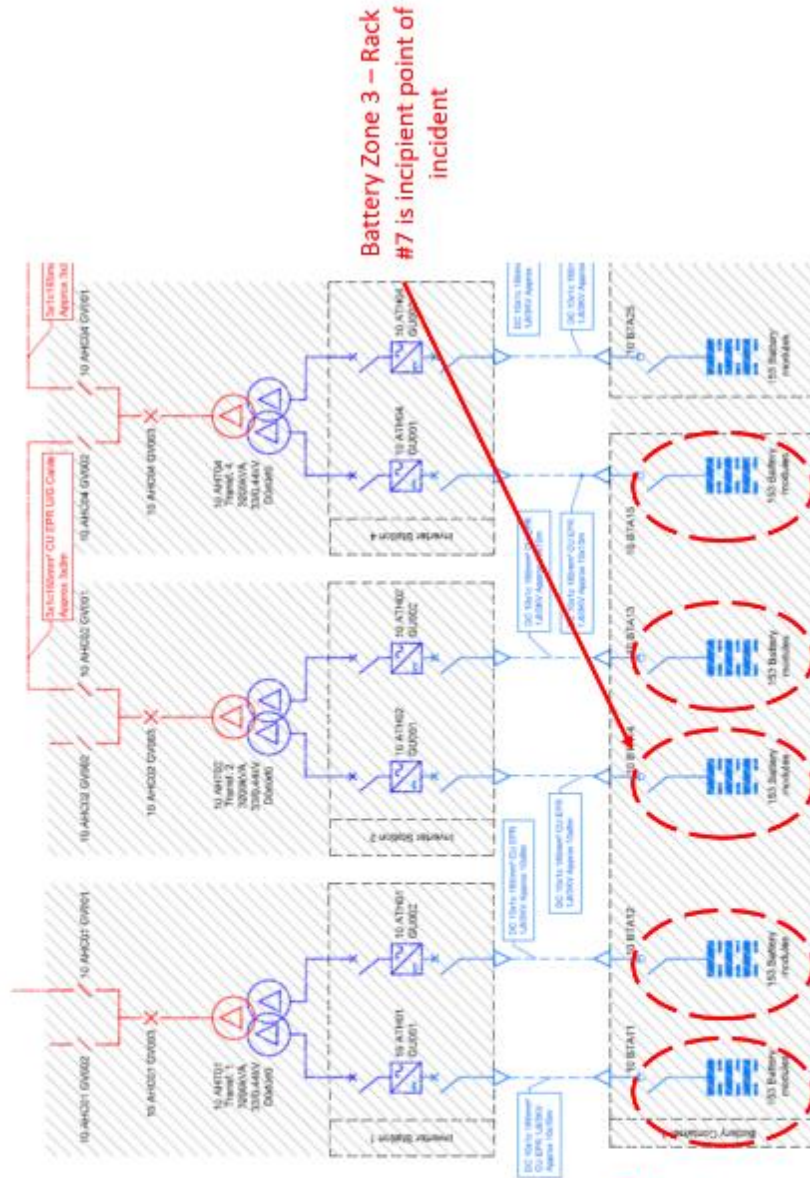
Plan 4<sup>13</sup>

Battery Zone 3 – Rack #7 is incident point of incident
